Manhole Inspection Summary

Manhole # S31A__001MH

Insp Date: **12/20/07 12:52 PM**

Location Address: **604 EUTAW ST**

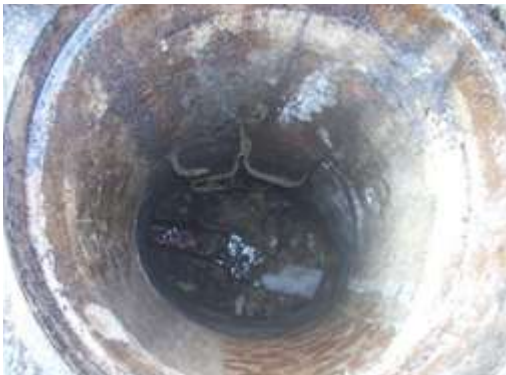
Defect 1

Steps Count: **4** Missing: **3** ☒ **Corroded**

MISSING AND CORRODED STEPS

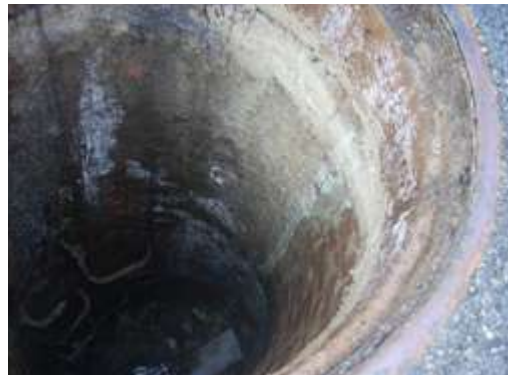
Defect 3

Surcharge ☒ **Evidence Of Surcharge** Depth: **6** (ft.) ☐ Active Surcharge Present

SURCHARGE EVIDENCE

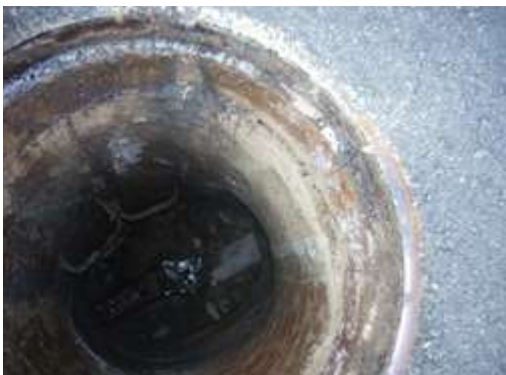
Defect 2

Frame Offset: **1** (in.) Condition: ☒ Sound ☐ Cracked ☐ Leaks

FRAME OFFSET

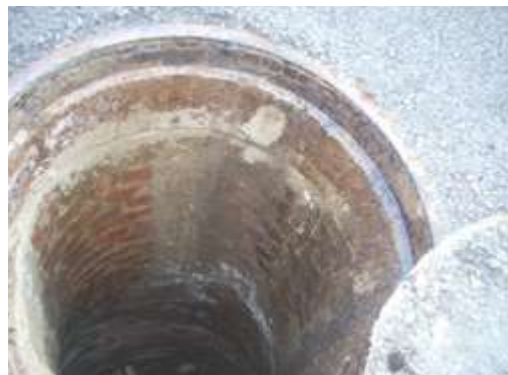
Defect 4

Infiltration: ☐ None ☒ **Joint** ☐ Cracks ☐ Mortar ☐ Roots ☐ Wall

corbel infiltration

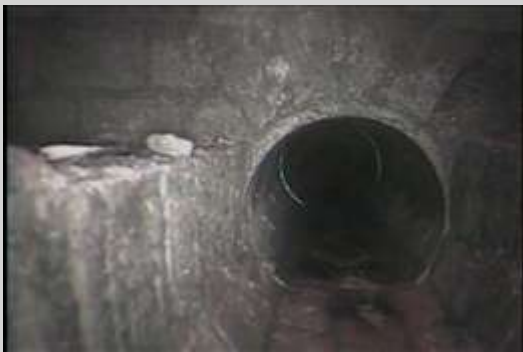
12 O'Clock Outflow

Pipe Height: **8.4** (in.) Rod and Bar (Angled)
Pipe Material: **Clay** ☐ Pipe Lined
Invert Depth: **11.13** (ft.) Flow Characteristics: **Slow**
Deposits: ☒ None ☐ Mud ☐ ~~Gravy~~ ☐ Debris ☐ Grease
Silt Depth: (in.) Deposits Extent:
Infiltration: **None** Pipe Seal Cond: **Sound**

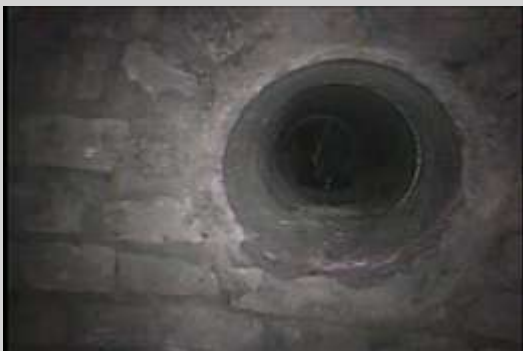
6 O'Clock Inflow

Pipe Height: **8.4** (in.) Rod and Bar (Angled)
Pipe Material: **Clay** ☐ Pipe Lined
Invert Depth: **9.15** (ft.) Flow Characteristics: **Slow**
Deposits: ☐ None ☐ Mud ☒ ~~Gravy~~ ☒ Debris ☐ Grease
Silt Depth: **6** (in.) Deposits Extent: **Heavy**
Infiltration: **None** Pipe Seal Cond: **Sound**

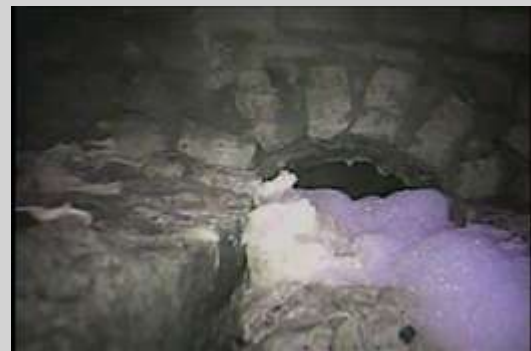
Drop In @ 6 O'Clock

Drop: **Outside** Rod and Bar
Angled: **Yes** Reading: **10.13** (ft.)
Inv Depth: **11.13** (ft.)

Drop Condition: **Open**
